**Flood Control Project Maintenance
Levee Inspections**
LMA District Cover Sheet
Spring 2013 Levee Inspection Results

City of Sacramento

Levee Inspection Report By Mile - Spring 2013

Waterway				Bank	Unit Miles	Inspection Start/End	Inspector
Unit No. 01 City of Sacramento				Left	3.63		John Williamson

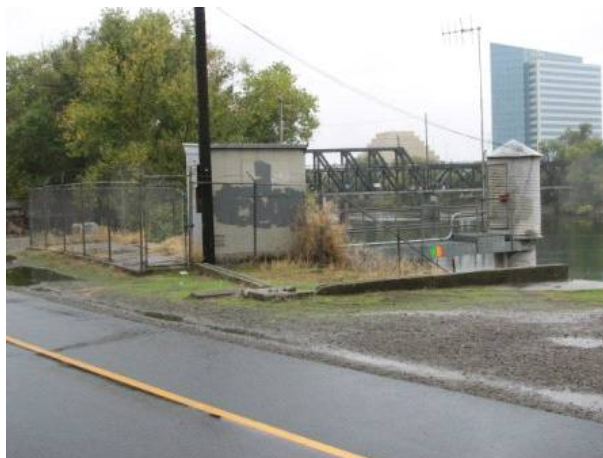
Levee Mile Report Line	4
Start Levee Mile	0.14
End Levee Mile	0.14
Location	Water Side
Category	
Item	Encroachments

View of the I Street recorder can.

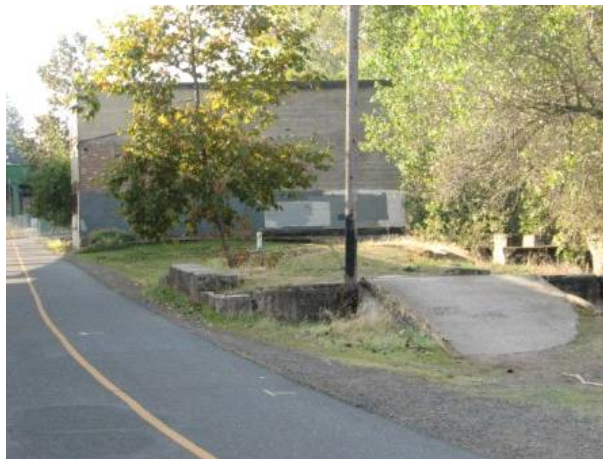
Levee Mile Report Line	5
Start Levee Mile	0.22
End Levee Mile	0.22
Location	Water Side
Category	
Item	Encroachments

Historical Building with foundations and ramps on upstream and downstream sides. Fall 2011

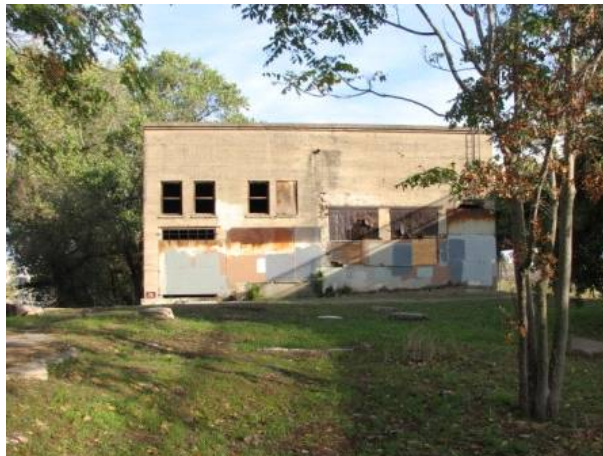
Levee Mile Report Line	5
Start Levee Mile	0.22
End Levee Mile	0.22
Location	Water Side
Category	
Item	Encroachments

A view of the south side of the building. Fall 2011

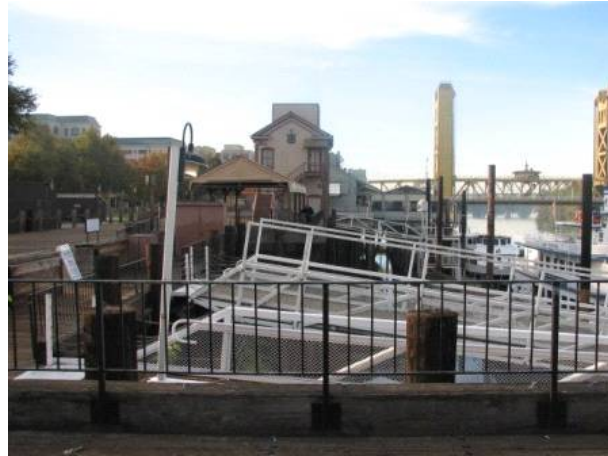
Levee Mile Report Line	6
Start Levee Mile	0.37
End Levee Mile	0.73
Location	Crown
Category	
Item	Encroachments

Photo looking downstream from the Delta King in Old Sacramento.

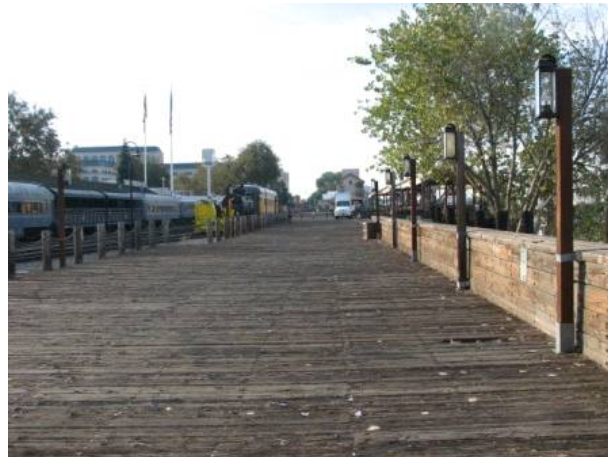
Levee Mile Report Line	6
Start Levee Mile	0.37
End Levee Mile	0.73
Location	Crown
Category	
Item	Encroachments

The wooden boardwalk in Old Sacramento on top of the flood wall. Fall 2011

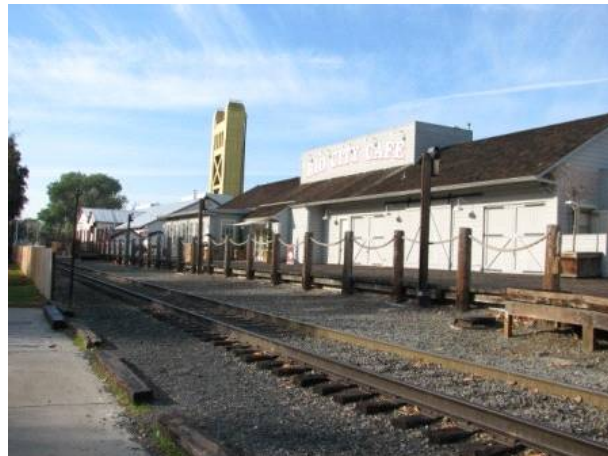
Levee Mile Report Line	6
Start Levee Mile	0.37
End Levee Mile	0.73
Location	Crown
Category	
Item	Encroachments

The buildings are on top of the flood wall and extend out over the river. Fall 2011

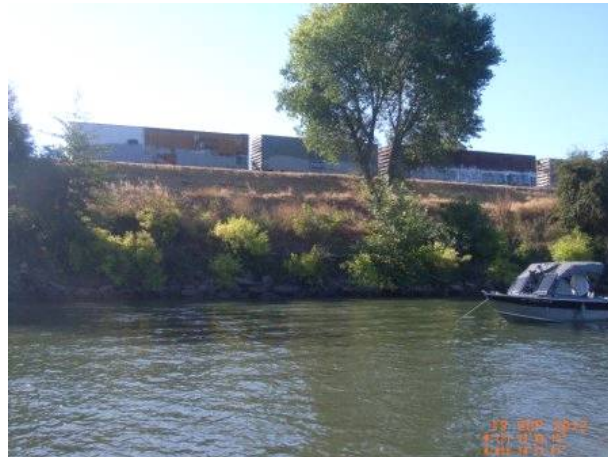
Levee Mile Report Line	8
Start Levee Mile	1.32
End Levee Mile	1.39
Location	Water Side
Category	Supplemental
Item	USACE Erosion Survey

USACE 2012 Photo #1

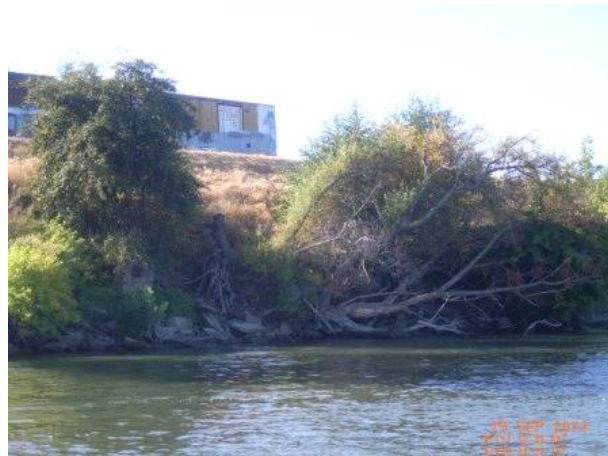
Levee Mile Report Line	8
Start Levee Mile	1.32
End Levee Mile	1.39
Location	Water Side
Category	Supplemental
Item	USACE Erosion Survey

USACE 2012 Photo #2

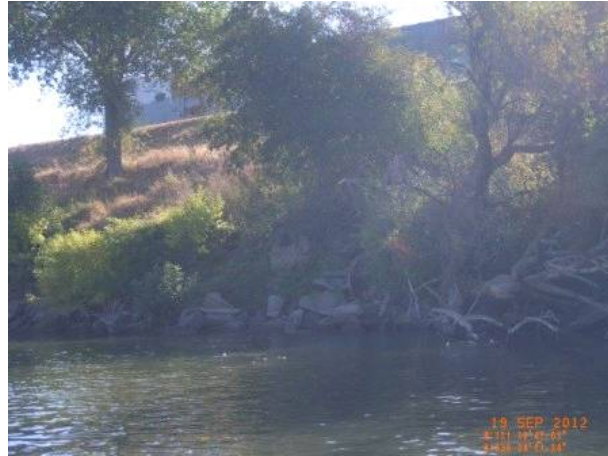
Levee Mile Report Line	8
Start Levee Mile	1.32
End Levee Mile	1.39
Location	Water Side
Category	Supplemental
Item	USACE Erosion Survey

USACE 2012 Photo #3

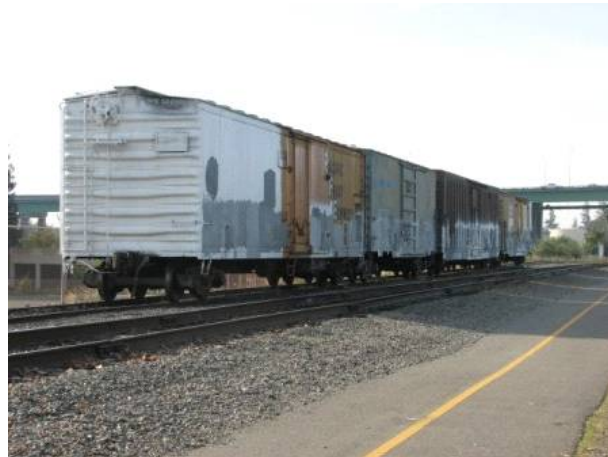
Levee Mile Report Line	9
Start Levee Mile	1.35
End Levee Mile	1.35
Location	Crown
Category	
Item	Encroachments

There have been an additional two box cars added to this area. Fall 2011

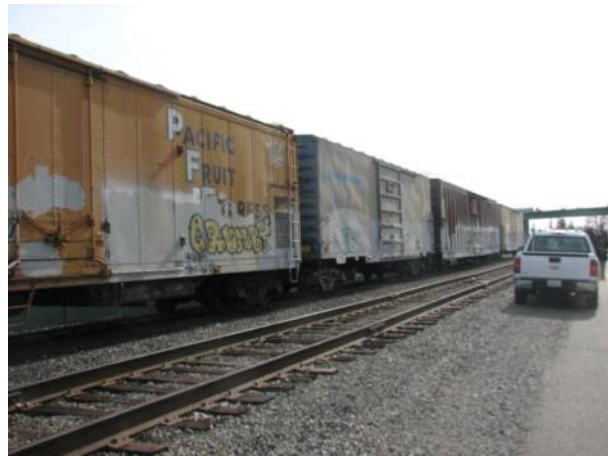
Levee Mile Report Line	9
Start Levee Mile	1.35
End Levee Mile	1.35
Location	Crown
Category	
Item	Encroachments

The number of box cars are the same and still in the same location Spring 2013

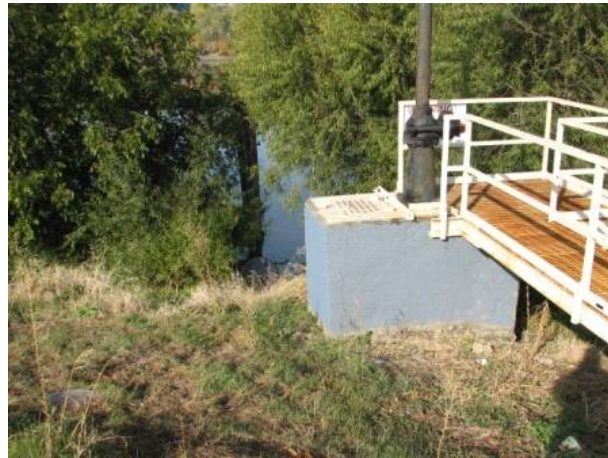
Levee Mile Report Line	10
Start Levee Mile	1.41
End Levee Mile	1.41
Location	Water Side
Category	
Item	Encroachments

The screw gate is the positive closure for the pipe. Fall 2011

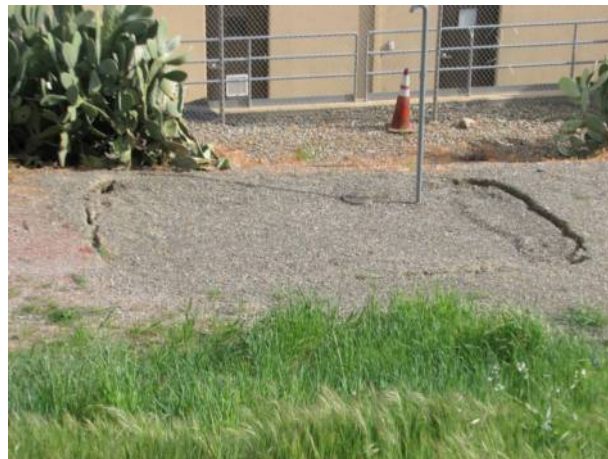
Levee Mile Report Line	11
Start Levee Mile	1.41
End Levee Mile	1.41
Location	Land Side
Category	
Item	Erosion / Bank Caving

The area along the toe of the levee has settled and needs to be looked at. Spring 2013

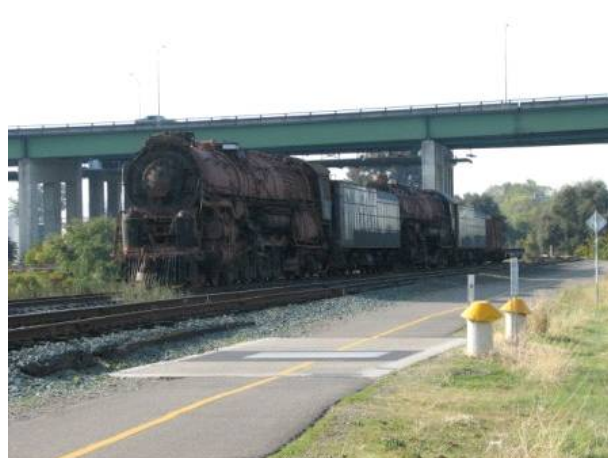
Levee Mile Report Line	12
Start Levee Mile	1.46
End Levee Mile	1.46
Location	Crown
Category	
Item	Encroachments

The two steam engines and other cars are stored on the levee. There is an agreement being worked on with the Railroad Museum and the City. This is to have the cars moved when necessary. Fall 2011

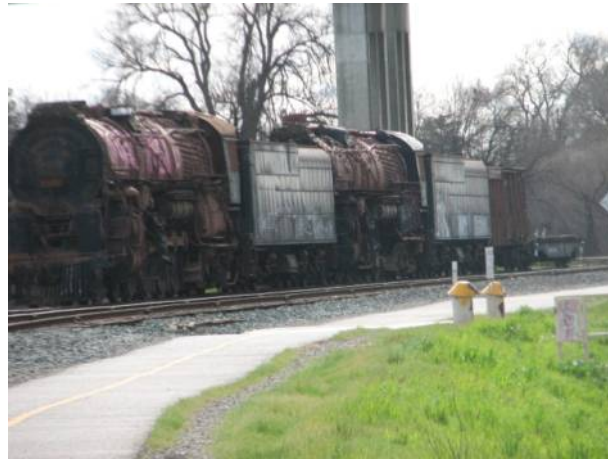
Levee Mile Report Line	12
Start Levee Mile	1.46
End Levee Mile	1.46
Location	Crown
Category	
Item	Encroachments

The engines and cars remain on the levee crown.
Spring 2013

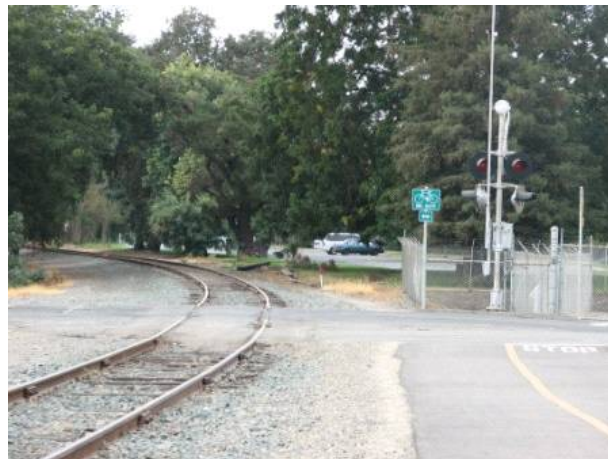
Levee Mile Report Line	13
Start Levee Mile	1.73
End Levee Mile	1.96
Location	Crown
Category	
Item	Encroachments

Miller Park at Broadway, railroad track and parking area on levee.

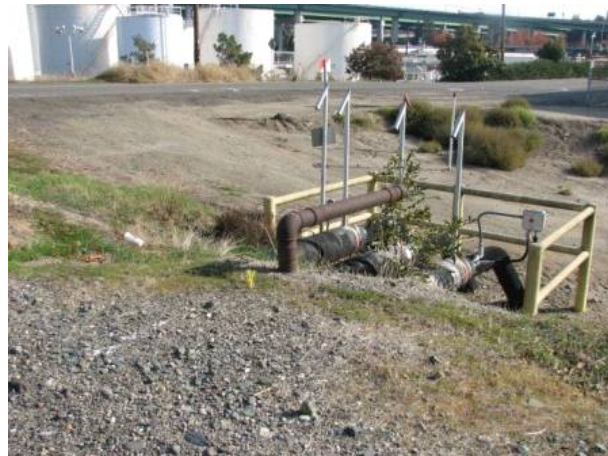
Levee Mile Report Line	14
Start Levee Mile	1.75
End Levee Mile	1.75
Location	Crown
Category	
Item	Encroachments

A pipe on the landside shoulder crosses under the railroad tracks. Fall 2011

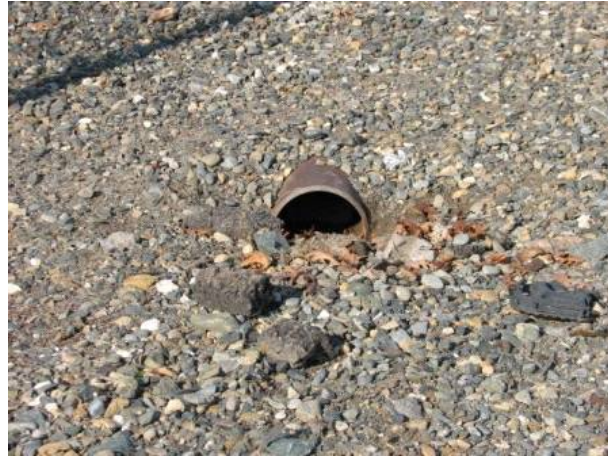
Levee Mile Report Line	14
Start Levee Mile	1.75
End Levee Mile	1.75
Location	Crown
Category	
Item	Encroachments

This appears to be a drain pipe under a driveway. It is a different pipe then the other photo for this issue. Fall 2011

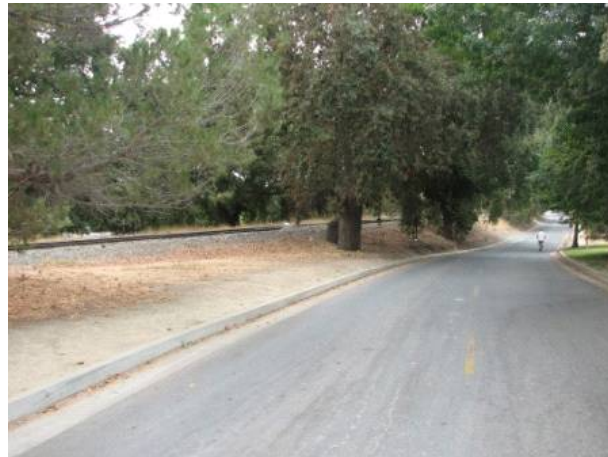
Levee Mile Report Line	15
Start Levee Mile	1.96
End Levee Mile	2.34
Location	Crown
Category	
Item	Encroachments

Railroad tracks are on levee crown. The street is to the boat ramp.

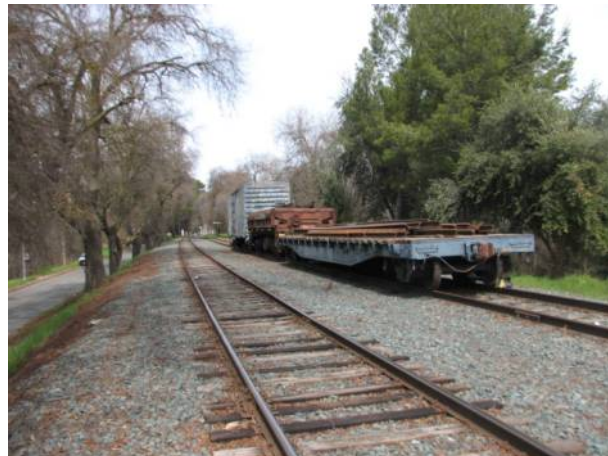
Levee Mile Report Line	15
Start Levee Mile	1.96
End Levee Mile	2.34
Location	Crown
Category	
Item	Encroachments

The railroad cars remain on the levee crown. Spring 2013

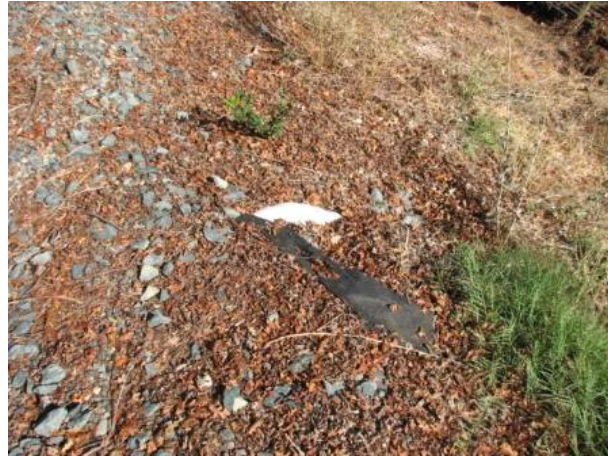
Levee Mile Report Line	16
Start Levee Mile	2.04
End Levee Mile	2.04
Location	Crown
Category	
Item	Encroachments
The pipe is a french drain under the railroad tracks. Was in the USACE report has not been resolved. Photo fall 2012.	
johngw_s_20130221_233.jpg

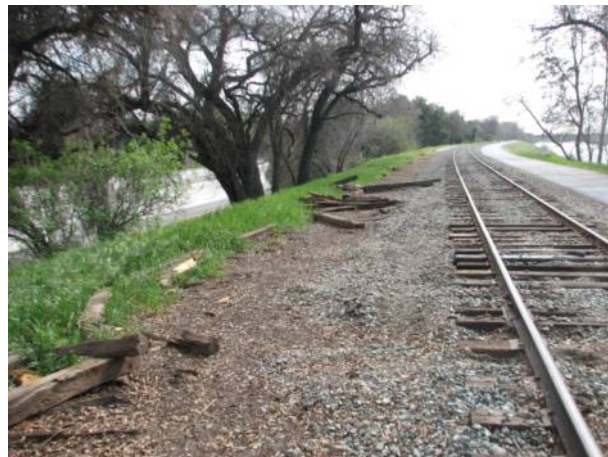
Levee Mile Report Line	17
Start Levee Mile	2.40
End Levee Mile	2.40
Location	Land Side
Category	
Item	Encroachments
Railroad ties have been removed and need to be picked up. Spring 2013	
johngw_s_20130325_826.JPG

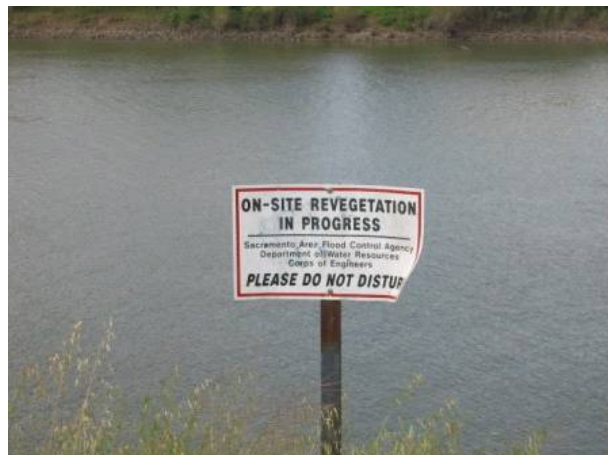
Levee Mile Report Line	19
Start Levee Mile	2.46
End Levee Mile	2.76
Location	Water Side
Category	
Item	Vegetation
This area is a revegetation site, photo taken spring 2012.	
johngw_s_20130221_229.jpg

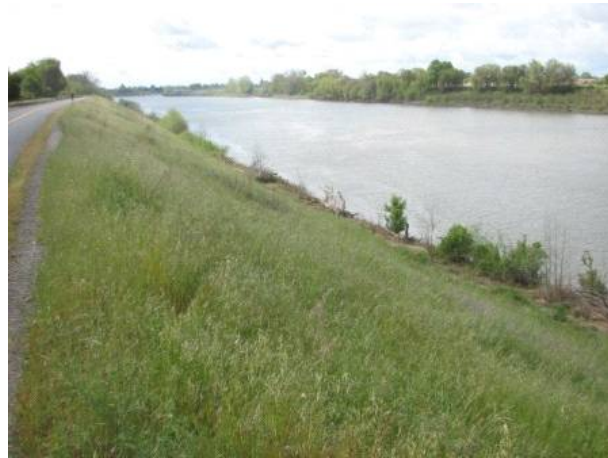
Levee Mile Report Line	19
Start Levee Mile	2.46
End Levee Mile	2.76
Location	Water Side
Category	
Item	Vegetation

A photo of the revegetation site taken spring 2012.

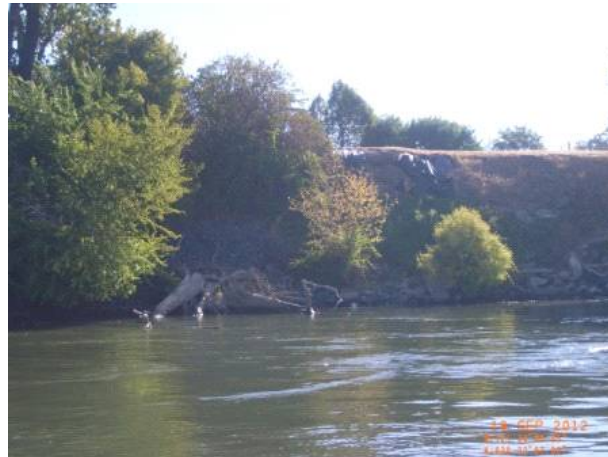
Levee Mile Report Line	20
Start Levee Mile	2.84
End Levee Mile	2.89
Location	Water Side
Category	Supplemental
Item	USACE Erosion Survey

USACE 2012 Photo #1

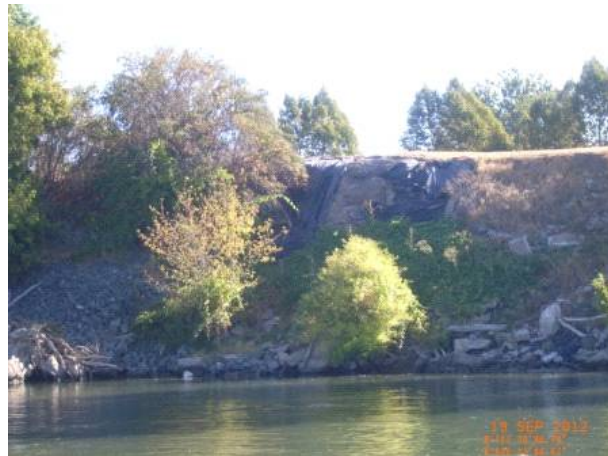
Levee Mile Report Line	20
Start Levee Mile	2.84
End Levee Mile	2.89
Location	Water Side
Category	Supplemental
Item	USACE Erosion Survey

USACE 2012 Photo #2

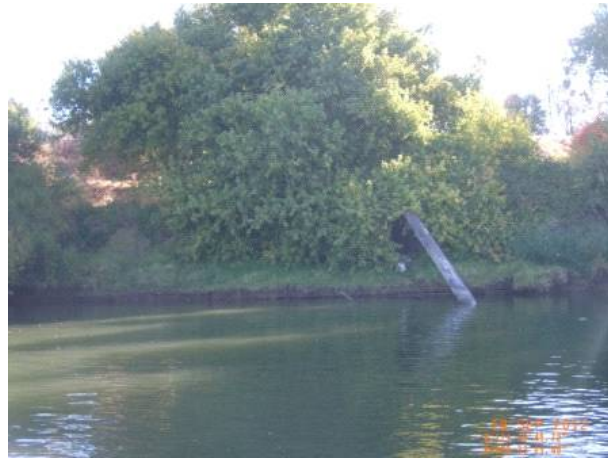
Levee Mile Report Line	20
Start Levee Mile	2.84
End Levee Mile	2.89
Location	Water Side
Category	Supplemental
Item	USACE Erosion Survey

USACE 2012 Photo #3

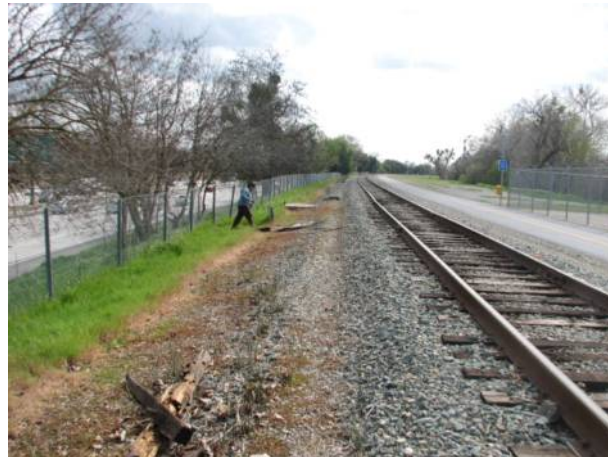
Levee Mile Report Line	21
Start Levee Mile	2.89
End Levee Mile	2.89
Location	Land Side
Category	
Item	Encroachments

More debris of railroad ties on levee crown Spring 2013

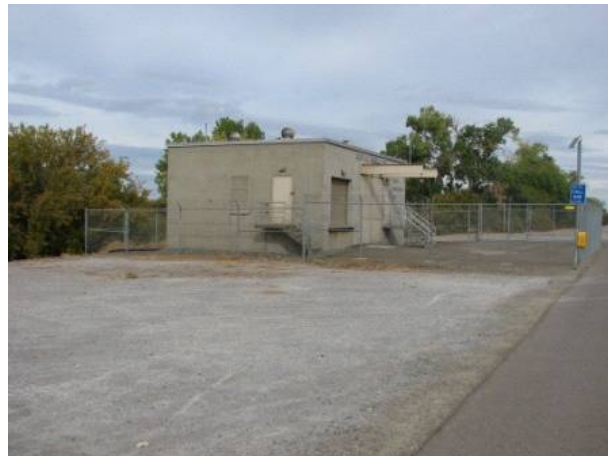
Levee Mile Report Line	22
Start Levee Mile	2.90
End Levee Mile	2.90
Location	Crown
Category	
Item	Encroachments

City of Sacramento pump station on the waterside of the crown of the levee.

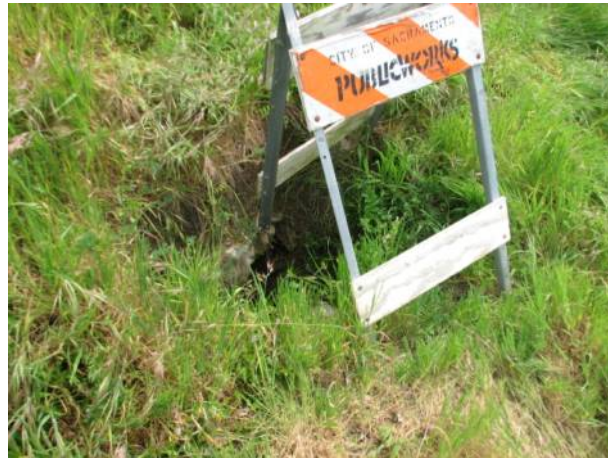
Levee Mile Report Line	23
Start Levee Mile	2.96
End Levee Mile	2.96
Location	Water Side
Category	
Item	Erosion / Bank Caving

A hole in the levee slope. Spring 2013

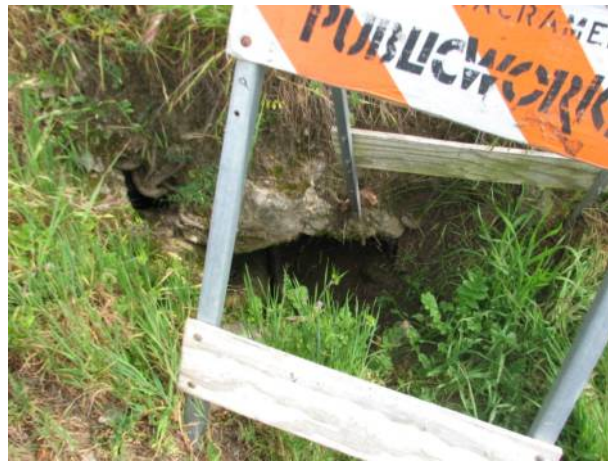
Levee Mile Report Line	23
Start Levee Mile	2.96
End Levee Mile	2.96
Location	Water Side
Category	
Item	Erosion / Bank Caving

A closer view of the hole in the waterside slope. Spring 2013

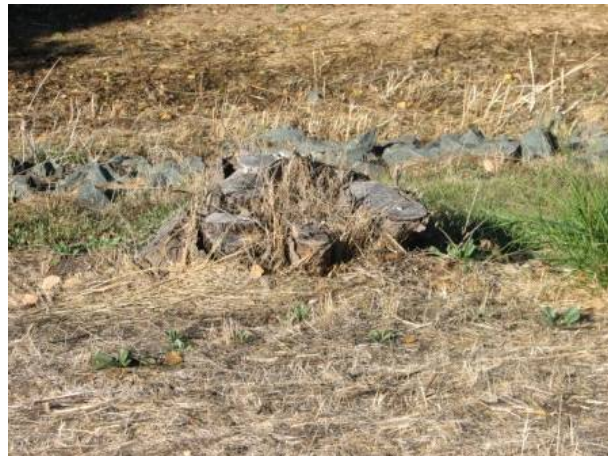
Levee Mile Report Line	24
Start Levee Mile	3.22
End Levee Mile	3.22
Location	Water Side
Category	
Item	Trim / Thin Trees

LMR No.	Levee Mile		Category	Item	Location *	Rating ** +	Action/Comment	GPS Latitude/Longitude		Issue No.
	Start	End						Start	End	Photo
24	3.22	3.22		Trim / Thin Trees	WS	N	T5 : Tree stumps.	38.547353 °	38.547353 °	16
						Ma		-121.510253 °	-121.510253 °	Y
DWR ID: DWR_NA0005_01_f_2012_16

There are several tree stumps in this area. The district have been monitoring and spraying the stumps. Photo fall 2012.
